**PRODUCT SERVICE ADVISORY**

**48MS-SE1PF2-M2 & 48MS-SE1PF1-M2, MultiSight Vision Sensors,  
Date code 0717 (2007 week 17) and EARLIER  
(Date code 0718 and later is GOOD product and not affected by this recall)**

Ref: ACIG 2007-06-002

Date: June, 2007

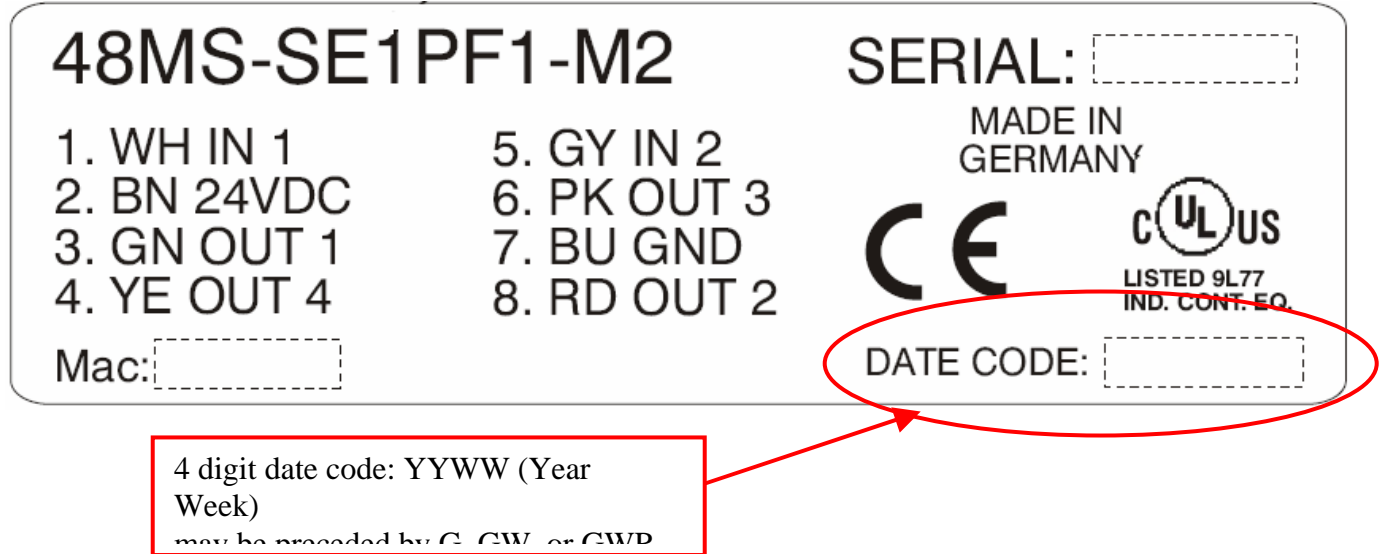
- 48MS-SE1PF2-M2 and 48MS-SE1PF1-M2, Date code 0717 (2007 week 17) and earlier
- Rockwell Automation shipped the potentially affected products between January and May 2007. (Parts shipped in June are not affected by this issue.)
- All pieces of these two part numbers that were shipped before June 2007 are potentially affected by this issue and need to be replaced. To confirm, refer to the date code. Anything before 0717 (2007 week 17) is potentially affected. The date code is on the sensor label (see illustration below). The date code could potentially be covered by the mounting bracket.
