**PRODUCT SERVICE ADVISORY**

**RSLogix 5000, version 16.00.00**

**When used with SoftLogix5800 or RSLogix Emulate 5000, Versions 16**

Ref: ACIG 2007-07-001

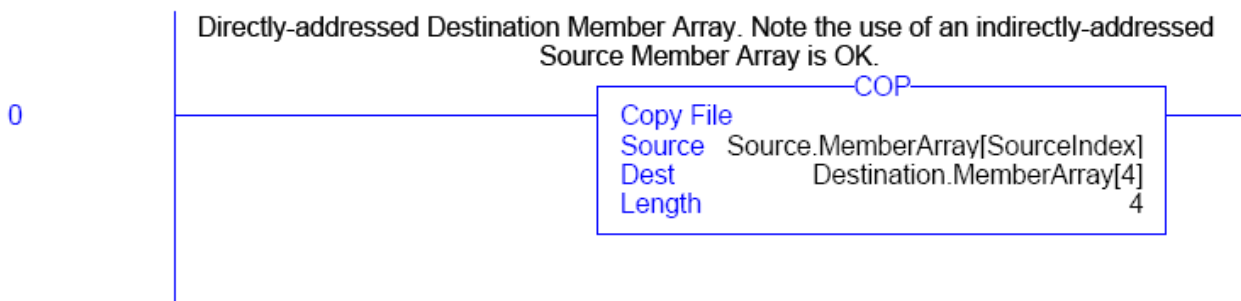
Example 1: Directly-addressed Member Array Use

This sample code would work properly because the destination member array used in the instruction is directly-addressed.

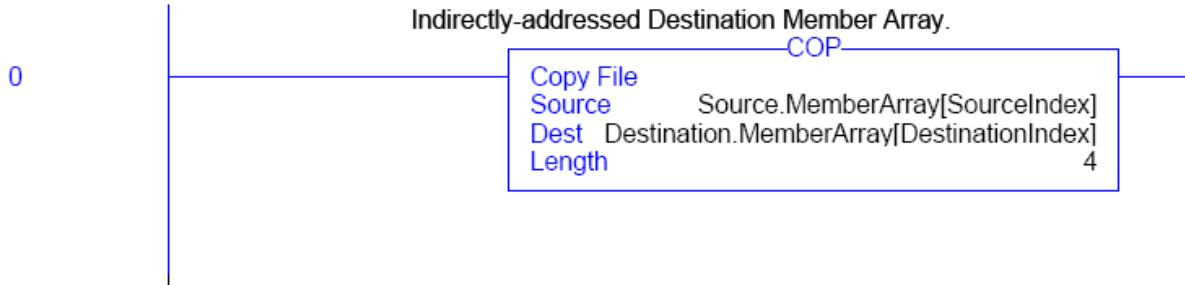
Example 2: Indirectly-addressed Member Array Use

The use of this sample code would result in anomalous behavior because the member array is indirectly-addressed.
